TEST REPORT 06E 109 217 / 218 H – V10-3166 & V10-3167

CLAIMED SAMPLE TESTING

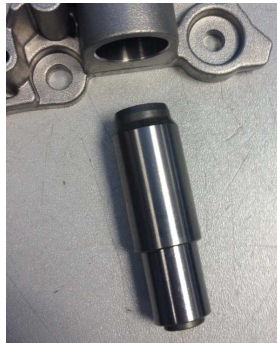
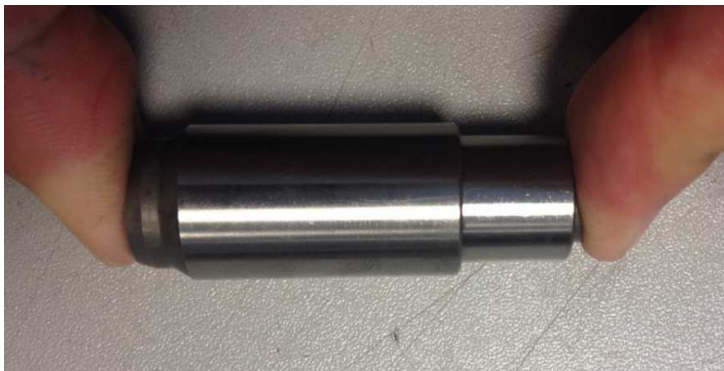
REASON 1: The initial tension of the spring inside the piston might be less than OE

TEST METHOD: we removed the pistons from the tensioners and checked the pressure of the inner spring.

RESULT: OE and VAICO have the same pressure and will provide the same initial tension on guide rail and chain . All returned samples show perfect performance for the spring and its initial tension

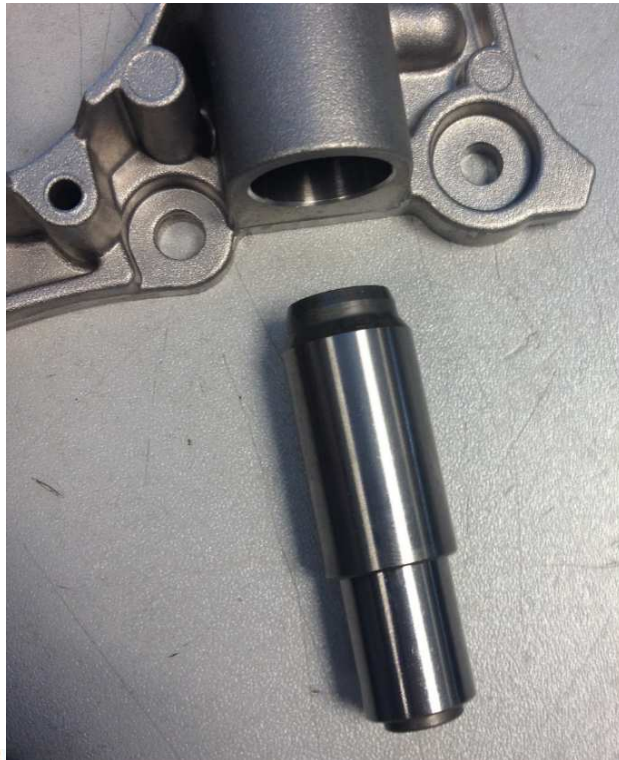
REASON 2: The surface of the piston or inner bore of the housing might be scratched or damaged and causes that the piston seizes and cannot put tension on the rail and chain

TEST METHOD: moving the piston inside the housing and removing it to check for scratches and damages

RESULT: None of the returned claim samples has surface damages on the piston or housing, the pistons can be moved in the bore easily and smoothly.

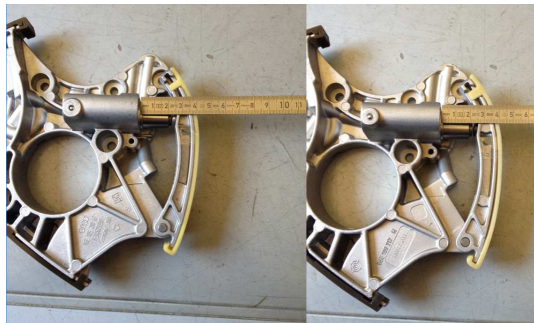
V10-3166:

REASON 3: The maximum lift of the piston of the VAICO tensioner might be less than OE

TEST METHOD: checking the position and distance after removing the locking key to check whether the piston brings the guide rail into correct position after mounting it and removing the key lock

RESULT: OE and VAICO tensioners have the same maximum lift. All returned items have the correct maximum lift values like OE and our inventory:

V10-3166 = 40 mm

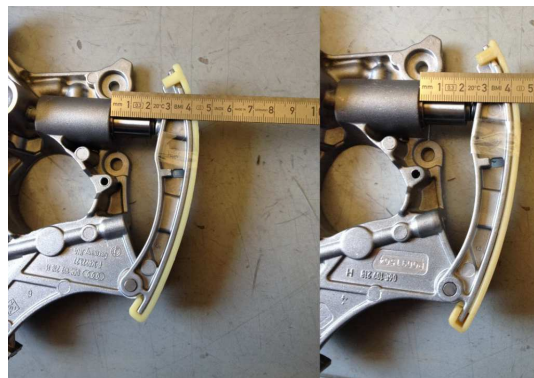
V10-3167:

V10-3167 = 43 mm

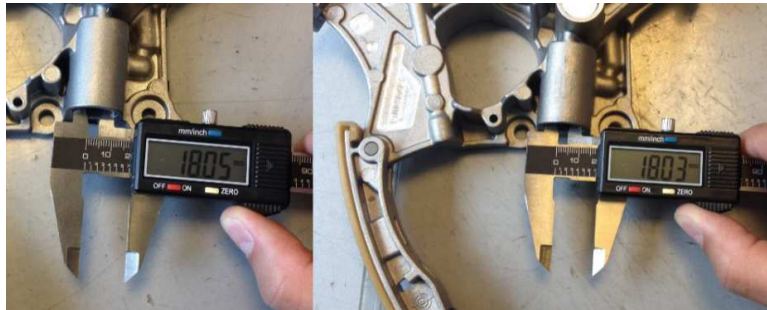
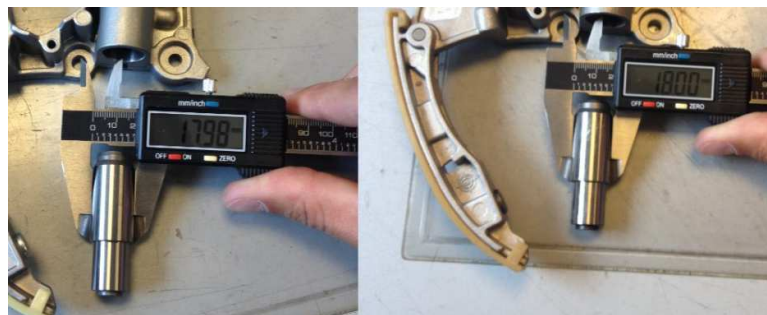
REASON 4: Different diameters of the piston and the bore might cause that too much oil can run through the space between so that the tensioner loses oil and tension pressure on the guide rail

TEST METHOD: comparing diameter of bolt and bore to genuine to check the space between

RESULT: The space between for OE is 0,07 mm and VAICO is 0,03 mm so that lower oil pressure on the VAICO piston cannot be the reason for too less tension. All returned samples show the same measures

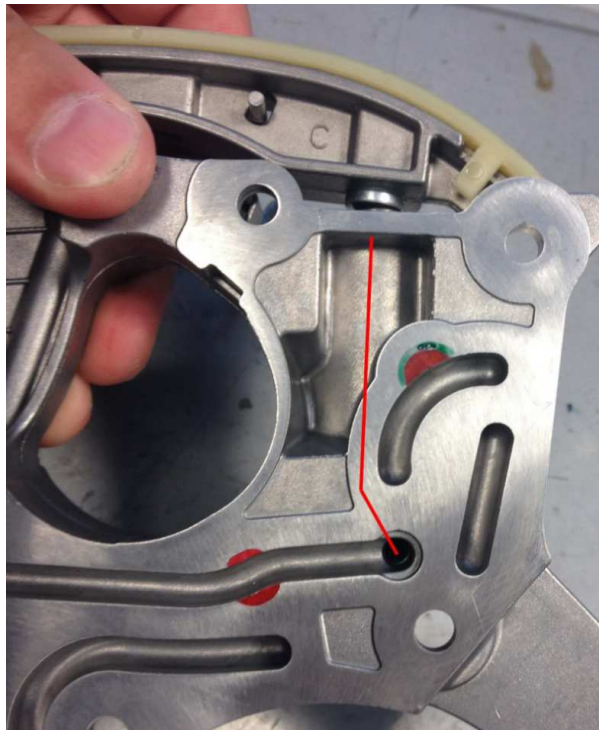
REASON 5: The oil tube leading pressure oil to the piston might be blocked or not drilled through so that no oil or less pressure reaches the piston

TEST METHOD: pressing the piston into the housing of the tensioner to check noises and air flow if the oil tube is blocked

RESULT: none of the returned tensioners has a blocked or not completely drilled oil tube so that the tensioners can build up correct tension if the oil pressure on the car is correct and all oil lines to the tensioner are clean and free.

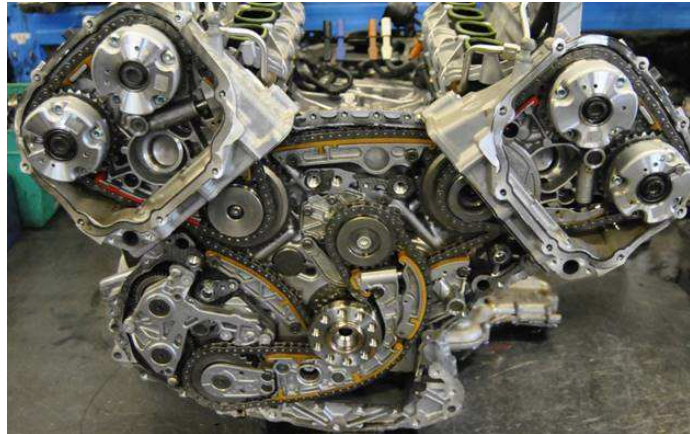
Main problem of all Audi 3.2 FSI engines is that the chains are mounted on the backside between engine and transmission so that you have to remove the complete engine to mount a new full timing chain kit with all chains, tensioners, rails etc. like shown in the following video <https://www.youtube.com/watch?v=6haUb4T5UG0>. In addition to that, this engine has massive problems with lengthened chains so that they have to repair it quite often.

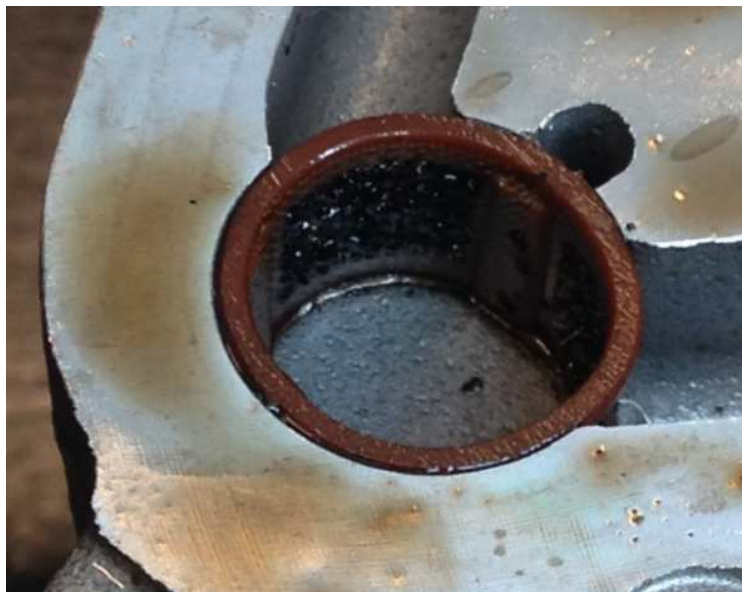
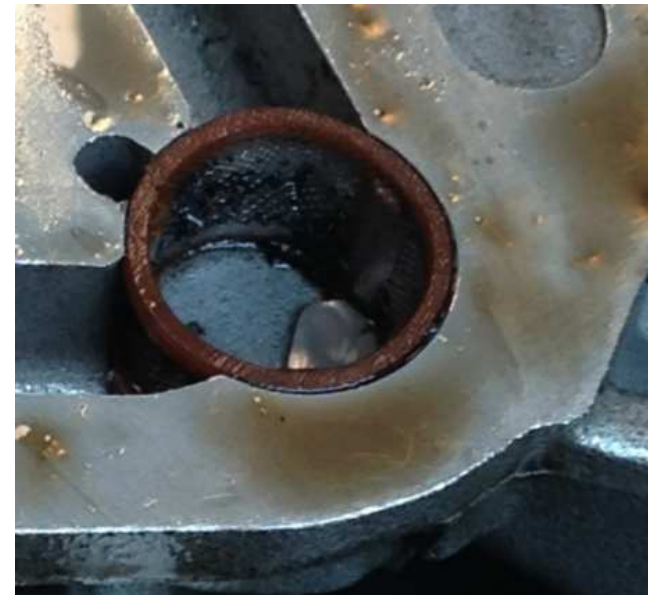
Another problem for these units is dirty oil. Two of the returned claim samples were driven with very old and dirty oil like shown on the following pictures where the little oil strainer was already full of dirt.

... they did not made an oil change after installing the new chain and tensioner

... tensioners and their strainers look dirty like on the picture before
