ADDITIV EOLYS

for diesel FAP particulate filter

AIC article no.: 58922 / Oe reference no.: 96 7803 3680

Additives against clogging in the diesel particulate filter

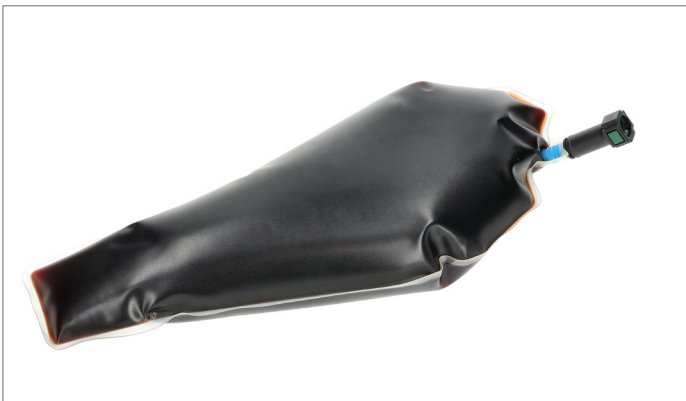
For short-distance journeys, diesel particulate filters have always been susceptible to clogging. Additives provide a solution.

For this reason, additives are used to ensure that the diesel particulate filter is cleaned even at low temperatures. When refueling, a portion of the additive (Eolys) is always mixed into the diesel. It leads to a reduction in the combustion temperature in the particulate filter. It impregnates the soot particles as they form in the combustion chamber, promoting combustion. PSA engines equipped with an FAP system have a bag containing the additive instead of a tank.
